# **REPORT CONSTRUCTION INVESTIGATION & RETAINAGE ASSURANCE**

NEW Multifamily HOUSE

85-87 Monitor Street

October 26, 2023

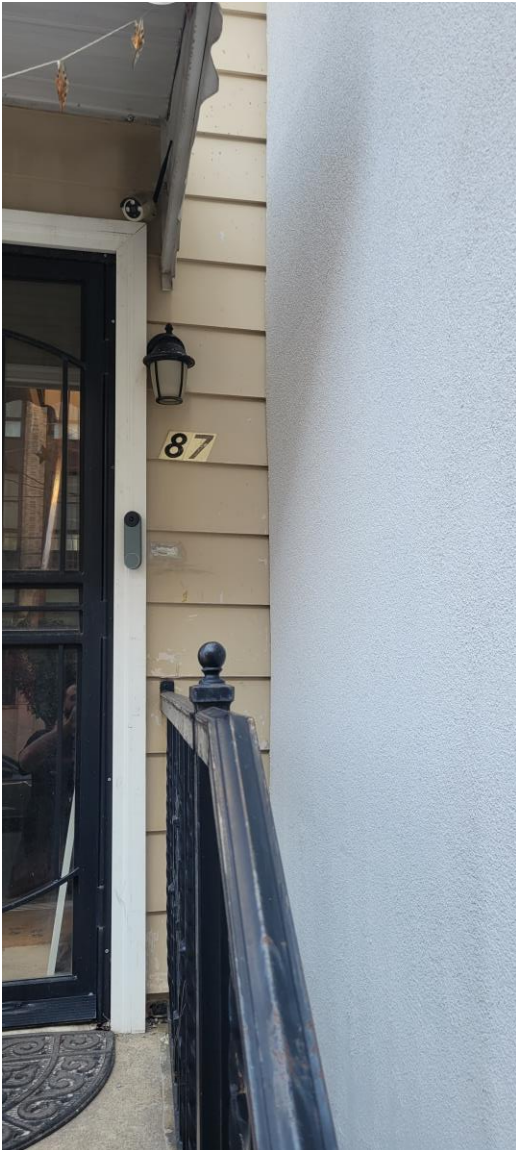
Photo 1-1: Front house view with connection to 87/89 Monitor

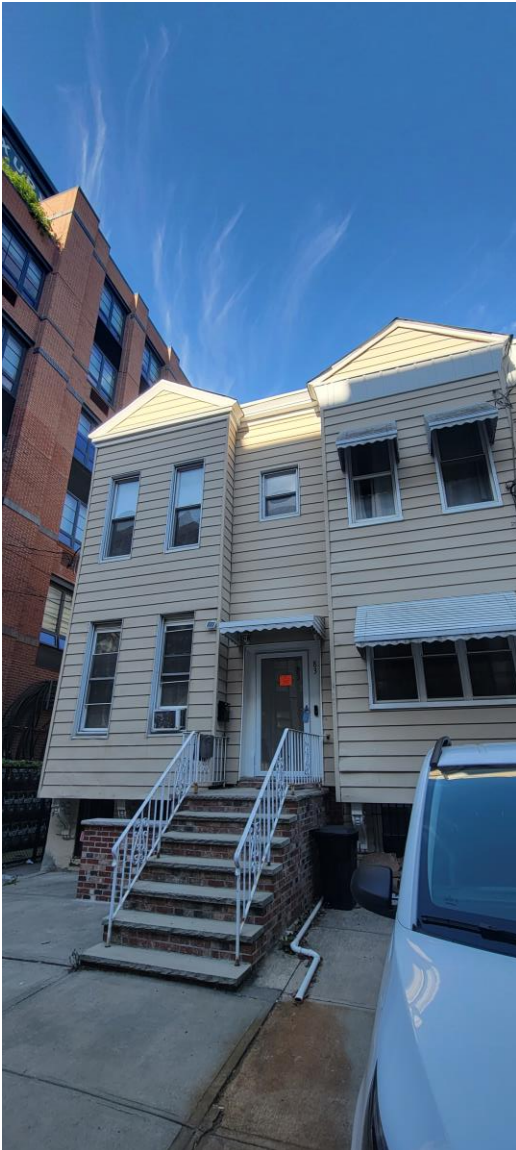
Photo 1-2: front view of house with 83/85 Monitor .

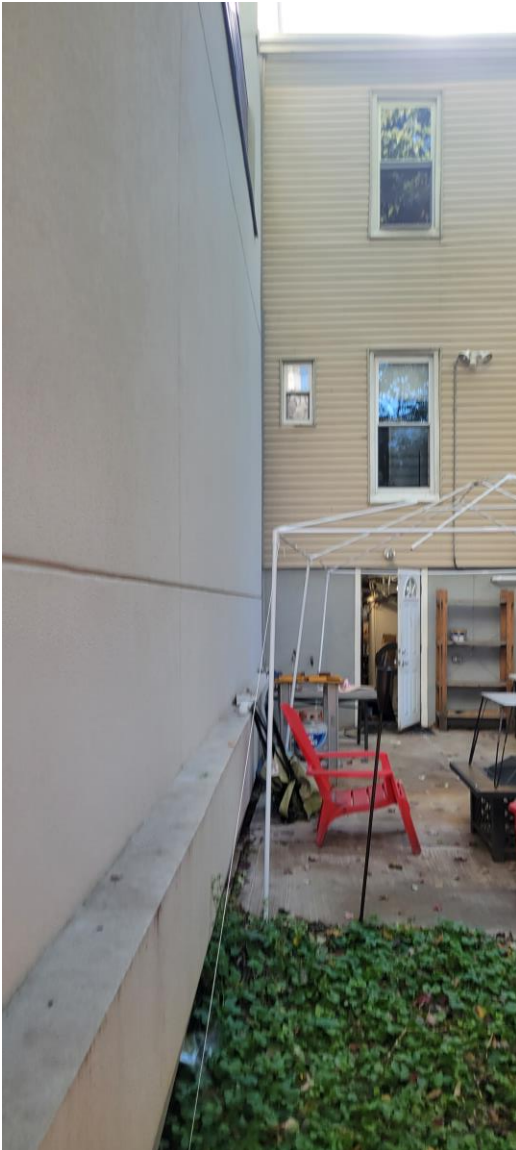
Photo 1-3: Rear view with connection with 87/89 Monitor
