MADONNA DESIGNS

St. Peter's Prep Grammar School Report 2/1/16

St. Peter's Grammar School

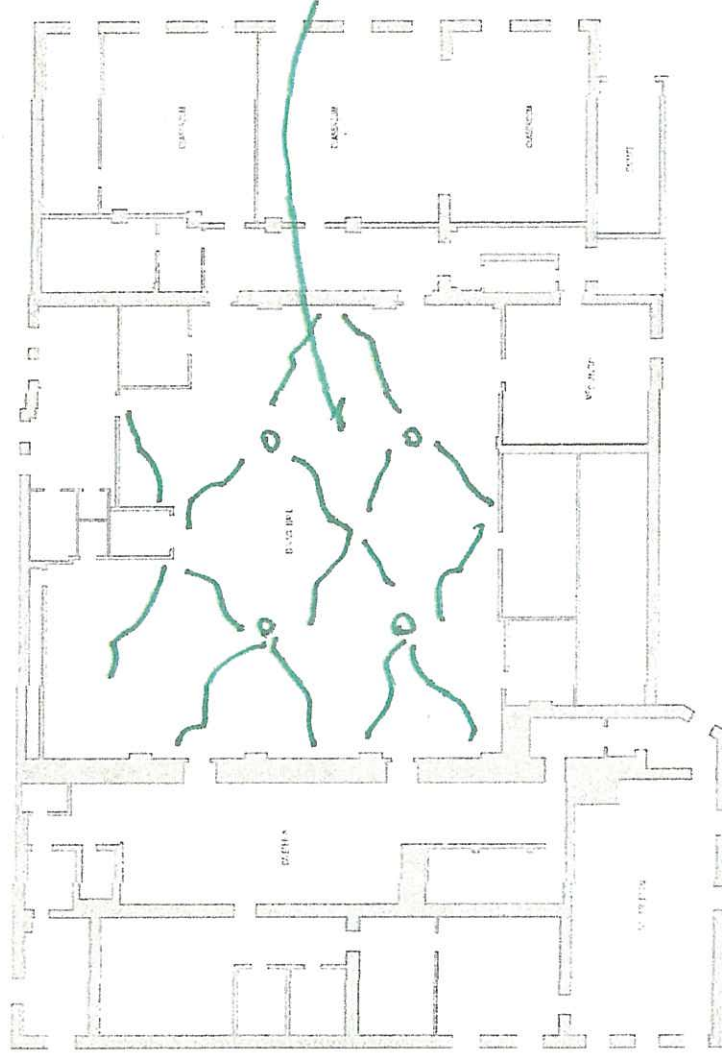
Basement Level
Saint Peter's Parochial School

The attached diagrams delineate the structural deficiencies. In the main cellar beneath the auditorium, the soil has eroded around all the columns creating an undulating slab. The columns while still supported by the timber piles now have little lateral support. The staircase along York Street at the main school entry has also sunk. The floor of the auditorium severely slopes to the stair whose foundation is now undermined. There is no way to practically re-support this stair and stabilize the foundation beneath it.

BUCKLING
CEILING
FLOOR
SLAB

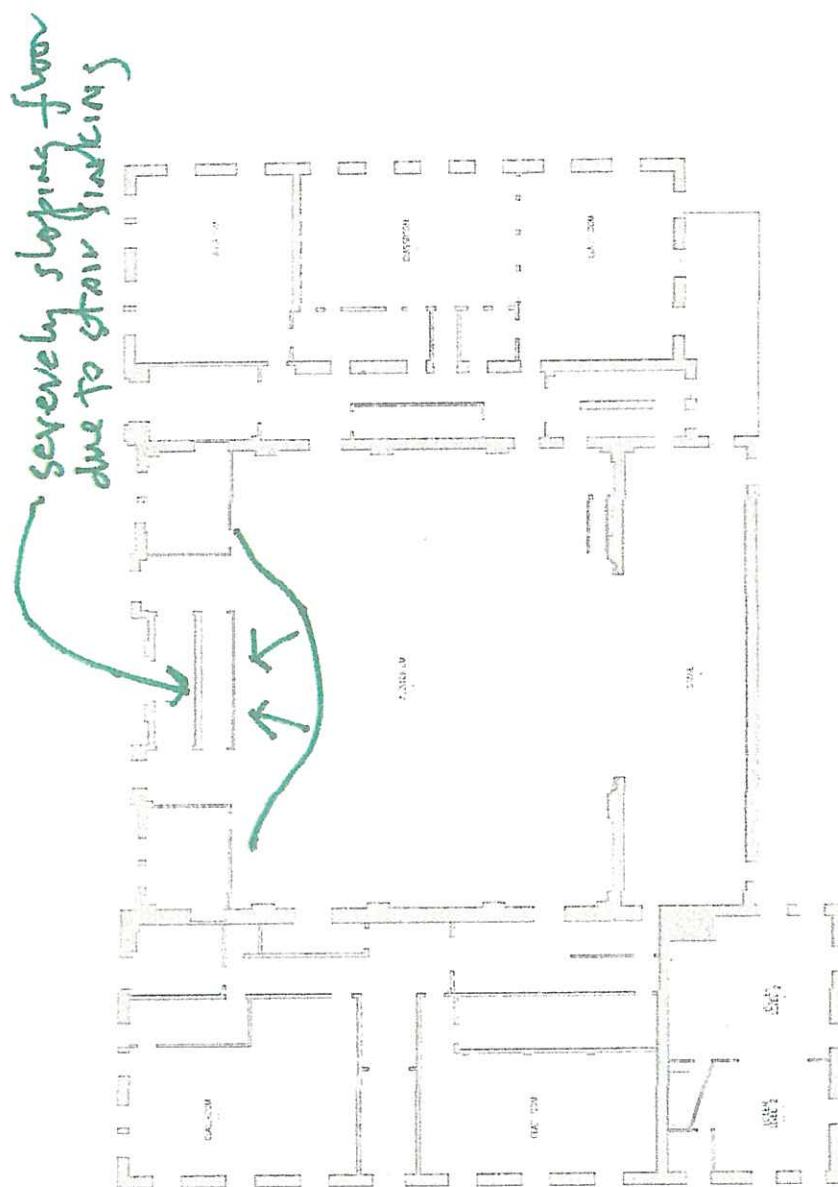
Ground Floor
Saint Peter's Parochial School

The west wall of the original school is bulging to the west with visible structural cracks displacing the staircase in the school extension. The stairs now are severely pitched. This original foundation wall which now sits on shifting soil is pushing on the corner structure.

STAIR CASE SLOPER
BUCKLING W/ LARGE STRUCTURAL CRACKS

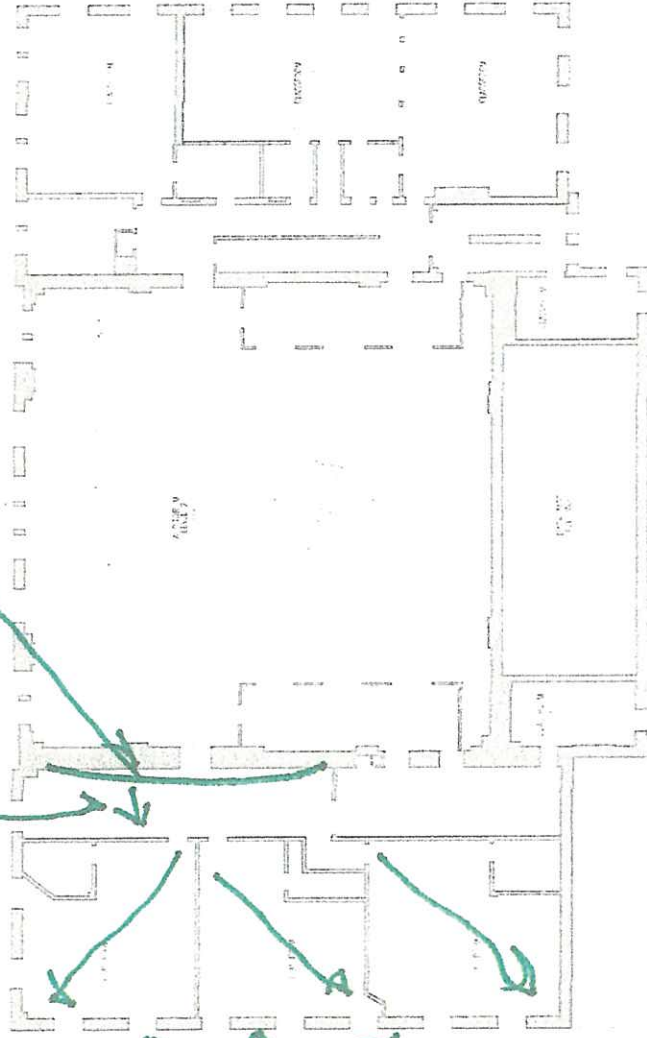
Second Floor
Saint Peter's Parochial School

The corner school extension has its own foundation and structural floor problems. All of the floors are considerably pitching west to the corner of the building. The floors are no longer level. These structural deformations are directly the result of the poor foundation and they strain the west façade on Van Vorst Street.

SEVERELY
SLOPED
FLOOR
