June 27, 2016 (*revised January 22, 2019*)

Saint Peter's Preparatory School
144 Grand Street
Jersey City, NJ 07302

Re: Assessment of Existing Foundation Conditions
Grammar School
Saint Peter's Preparatory School
Jersey City, New Jersey
MRCE File No. 12787

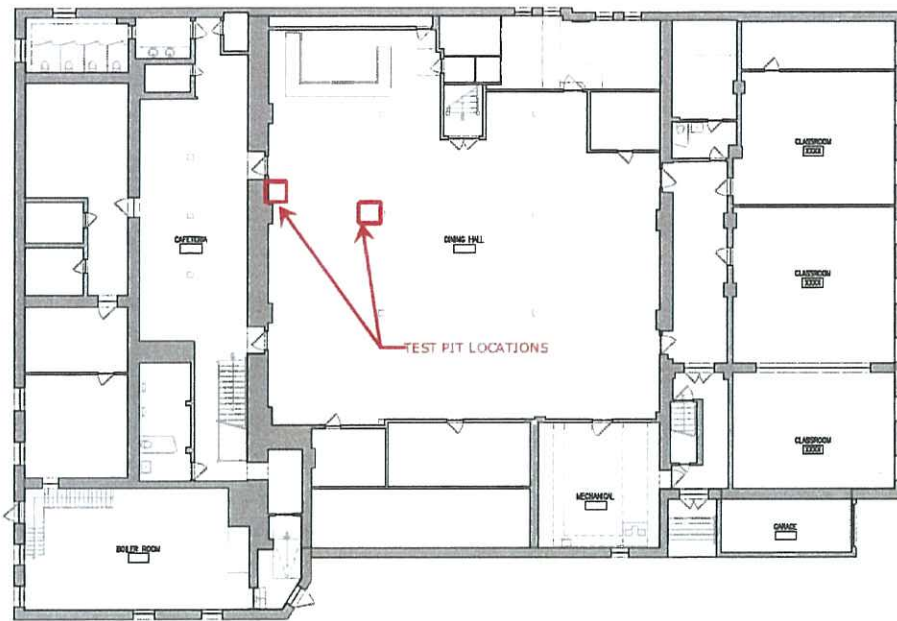
TEST PIT LOCATION PLAN

In 2018, two test pits were excavated in the building cellar. The test pit locations are shown on the attached plan. One of the test pits was excavated adjacent to an interior column and the other test pit was excavated adjacent to a bearing wall. Photos of the test pits are shown on Photos 1 and 2, attached. The test pit at the column exposed a brick pier supported on timber mat at a depth of about 4 feet just below the groundwater table. Probing by the excavation contractor suggest presence of timber piles below the piers. Based on our pencil cores of the mat timber, its condition is fair considering its age. The column test pit was not extended deeper as excessive dewatering would be required to do that. The wall test pit exposed the wall supported on brick foundation wall likely supported on a timber mat as well. The test pit was terminated at the groundwater table.

Basement Level TEST PIT LOCATIONS

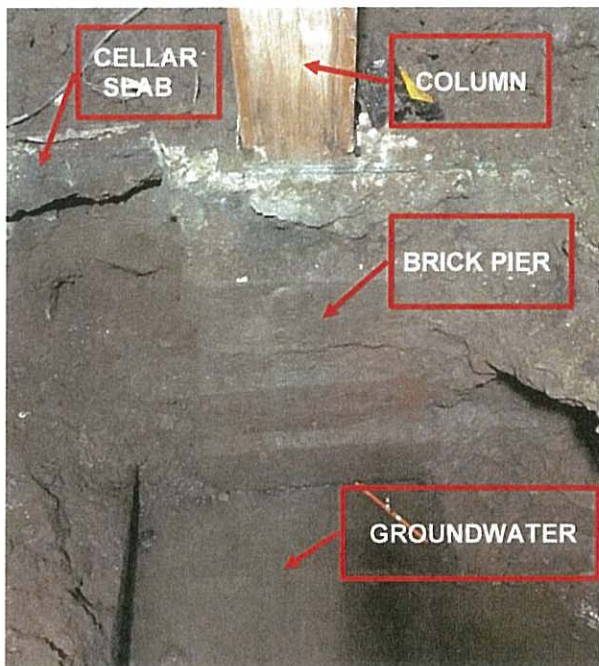
COLUMN TEST PIT PHOTOS

Test pit without dewatering.

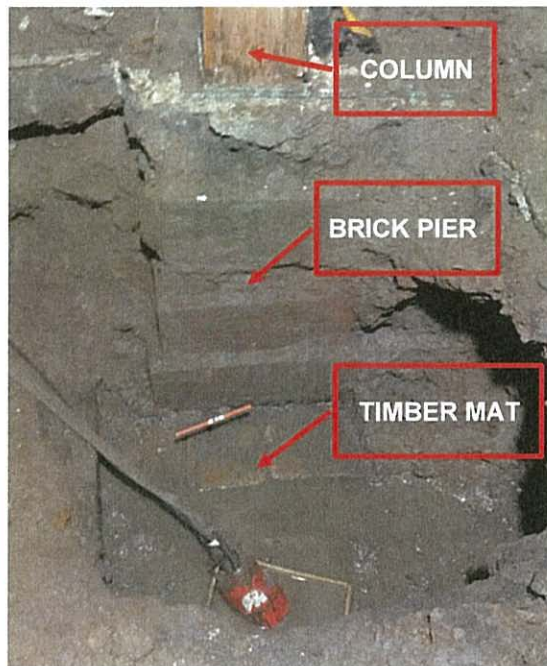
Test pit with dewatering.

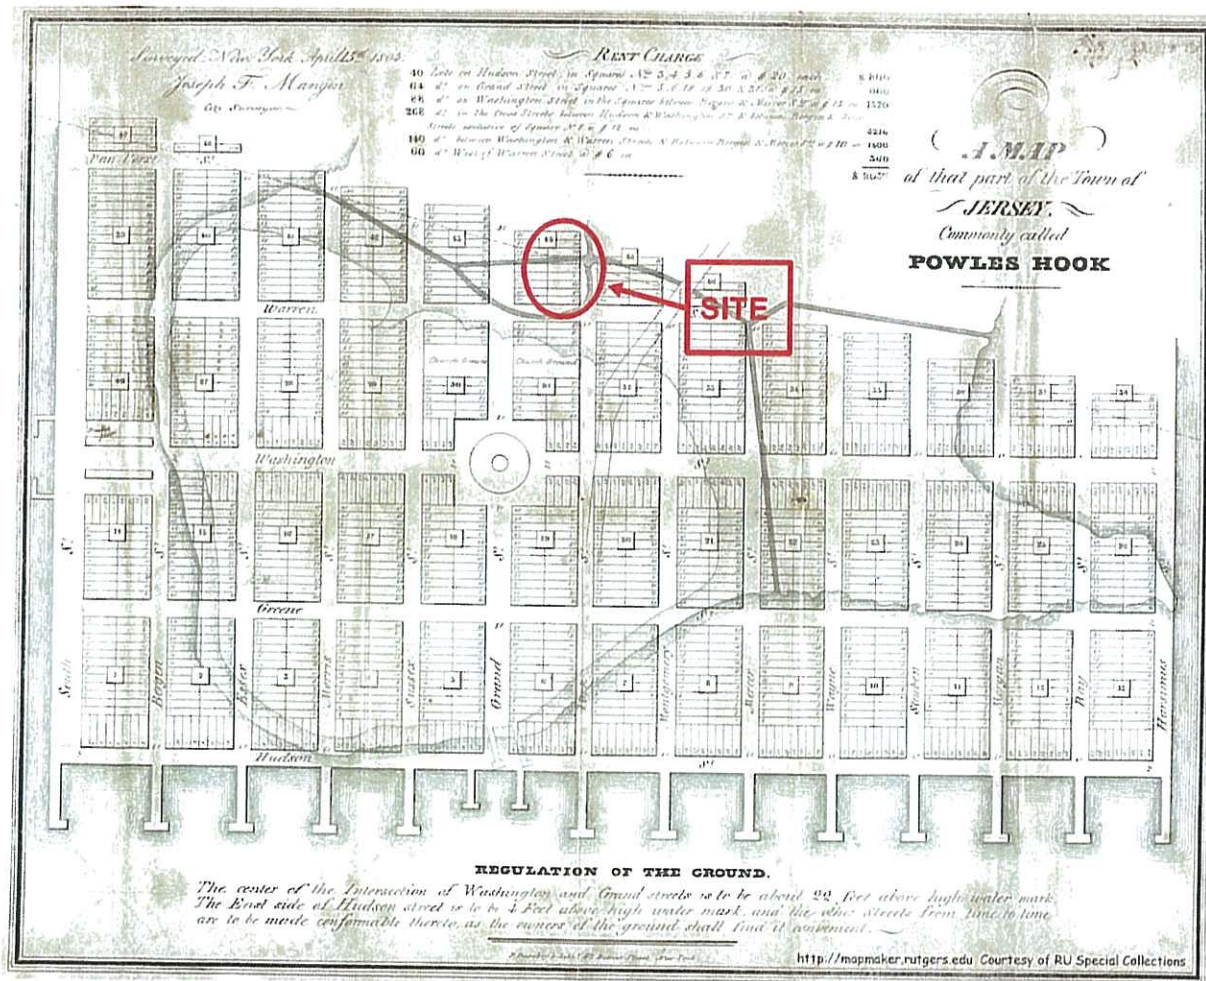
1840 MAP OF JERSEY CITY

Historic maps, e.g., 1804 map attached, indicate the grammar school site is the area of old streams likely surrounded by marshlands. Remnants of the old stream bottom or marsh deposits are typically found in such areas. These deposits are highly compressible and results in ground settlements when fills or structures are placed on top of them, unless piles are used.
