**REPORT CONCERNING THE DETERMIATION OF THE
CENTRAL AVENUE BLOCK 2901 STUDY AREA
AS AN AREA IN NEED OF REDEVELOPMENT AND AS A NON-CONDEMNATION
REDEVELOPMENT AREA**

OCTOBER 11, 2018

Prepared by
Division of City Planning
City of Jersey City

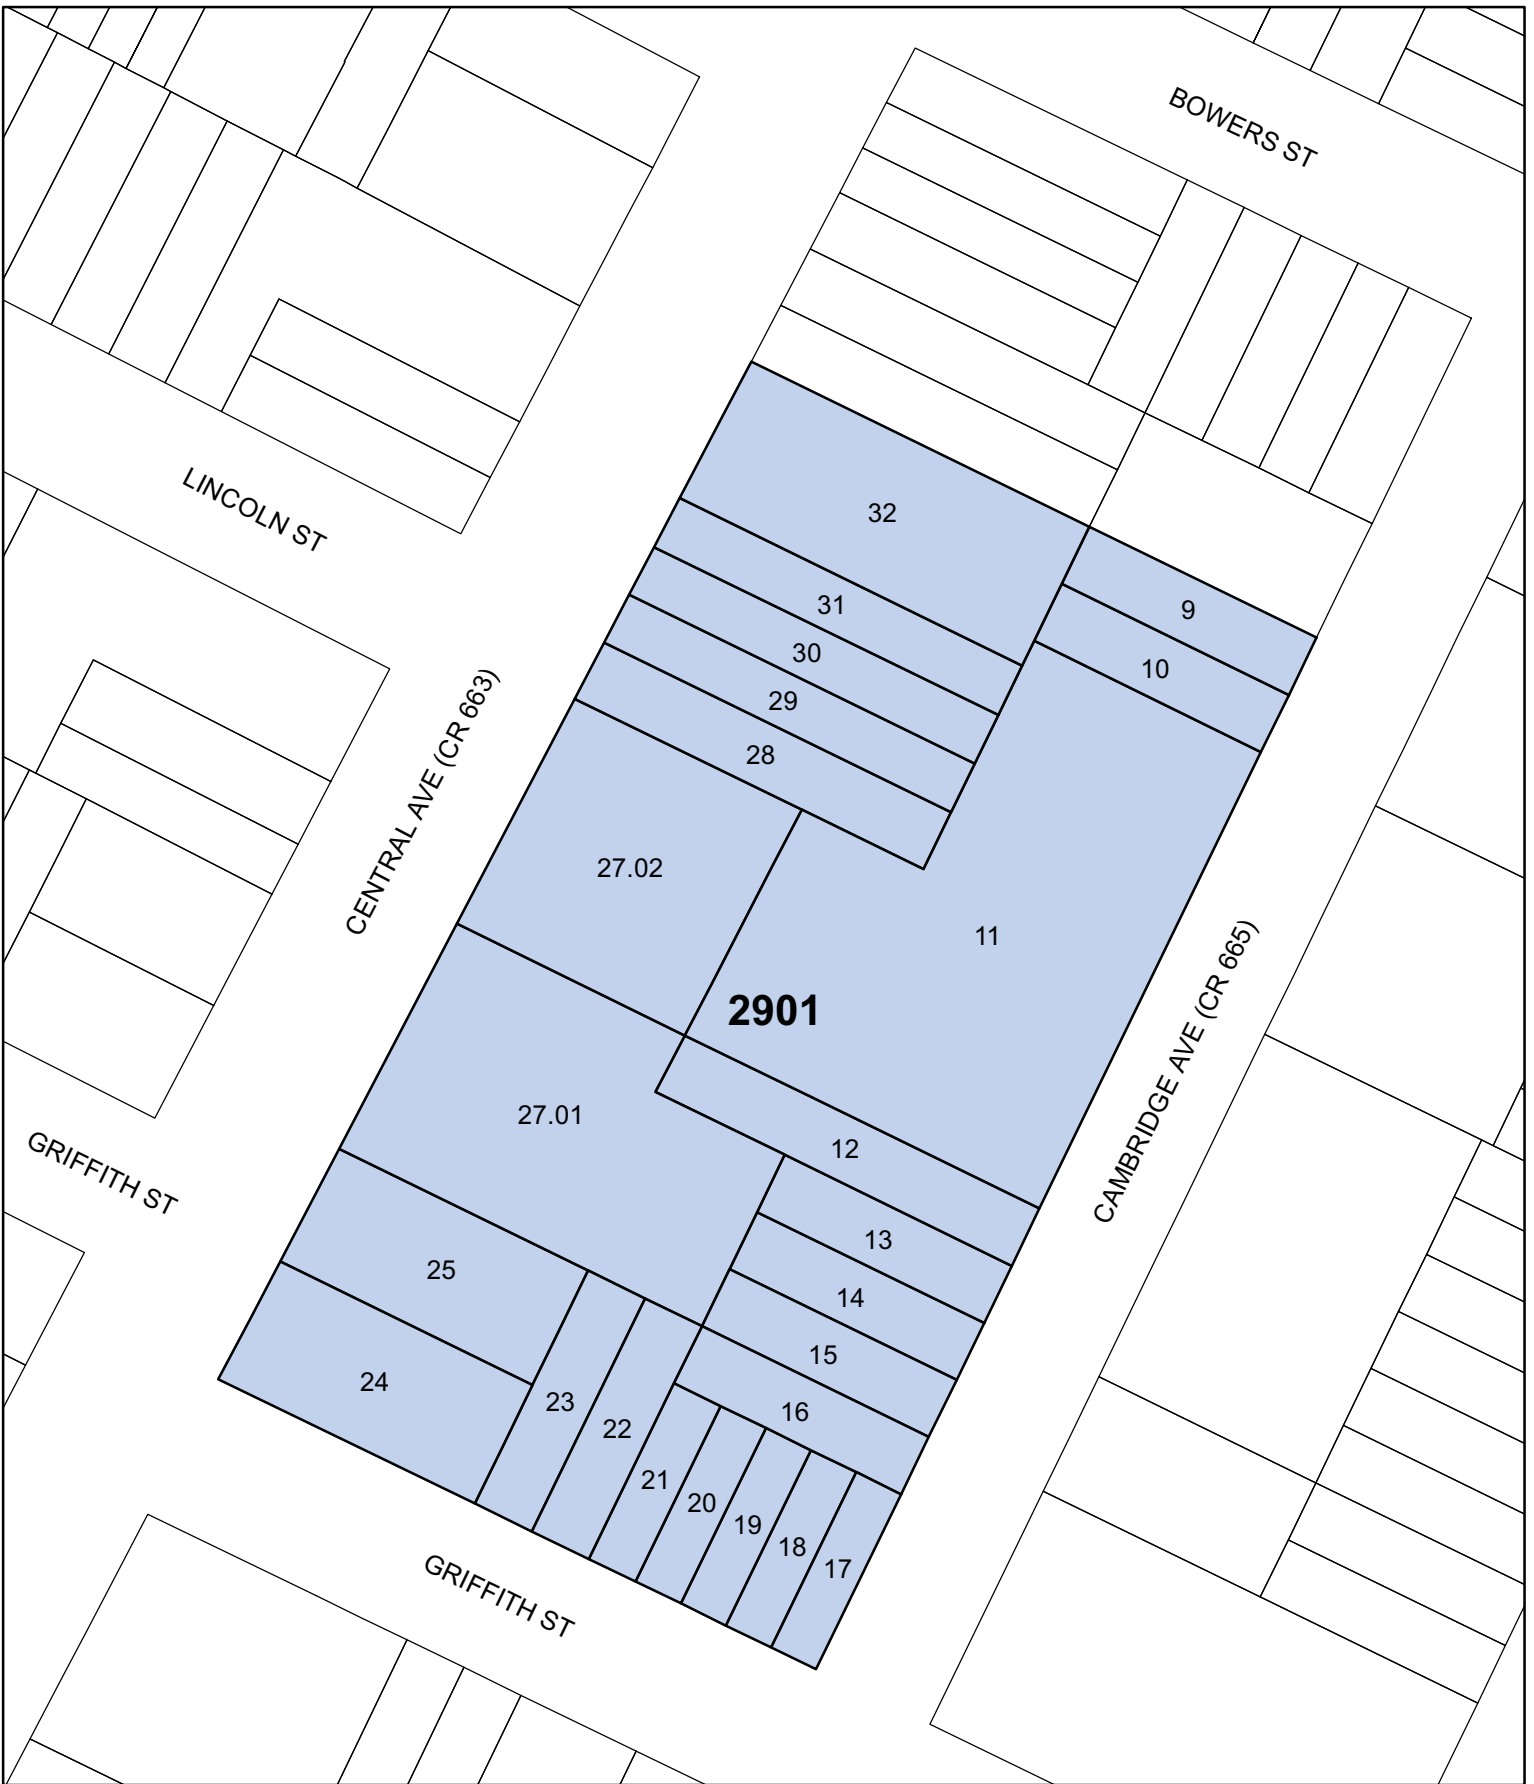
CENTRAL AVENUE BLOCK 2901 STUDY AREA
MAP A: PARCEL MAP

The Study Area consists of 24 parcels located in Block 2901 as shown in Map A in Appendix 1 of this study. The Study Area is bounded by Central Avenue to the west, Griffith Street to the south, and Cambridge Avenue to the east and to the north other parcels in Block 2901 (which are not part of this study). The Parcel Map (Map A) indicates the real property limits of the Study Area and the Proposed Redevelopment Area Map (Map D) indicates a potential boundary of a redevelopment plan and includes adjacent public right-of-ways. The properties included in the Study Area are also known as Block 2901, Lots 9, 10, 11, 12, 13, 14, 15, 16, 17, 18, 19, 20, 21, 22, 23, 24, 25, 27.01, 27.02, 28, 29, 30, 31, and 32 on the Jersey City Tax Map. Some properties also have qualifiers per the tax record. A full list of the taxable items by address, block, lot and qualifier is below as listed in the City’s Mod IV database:

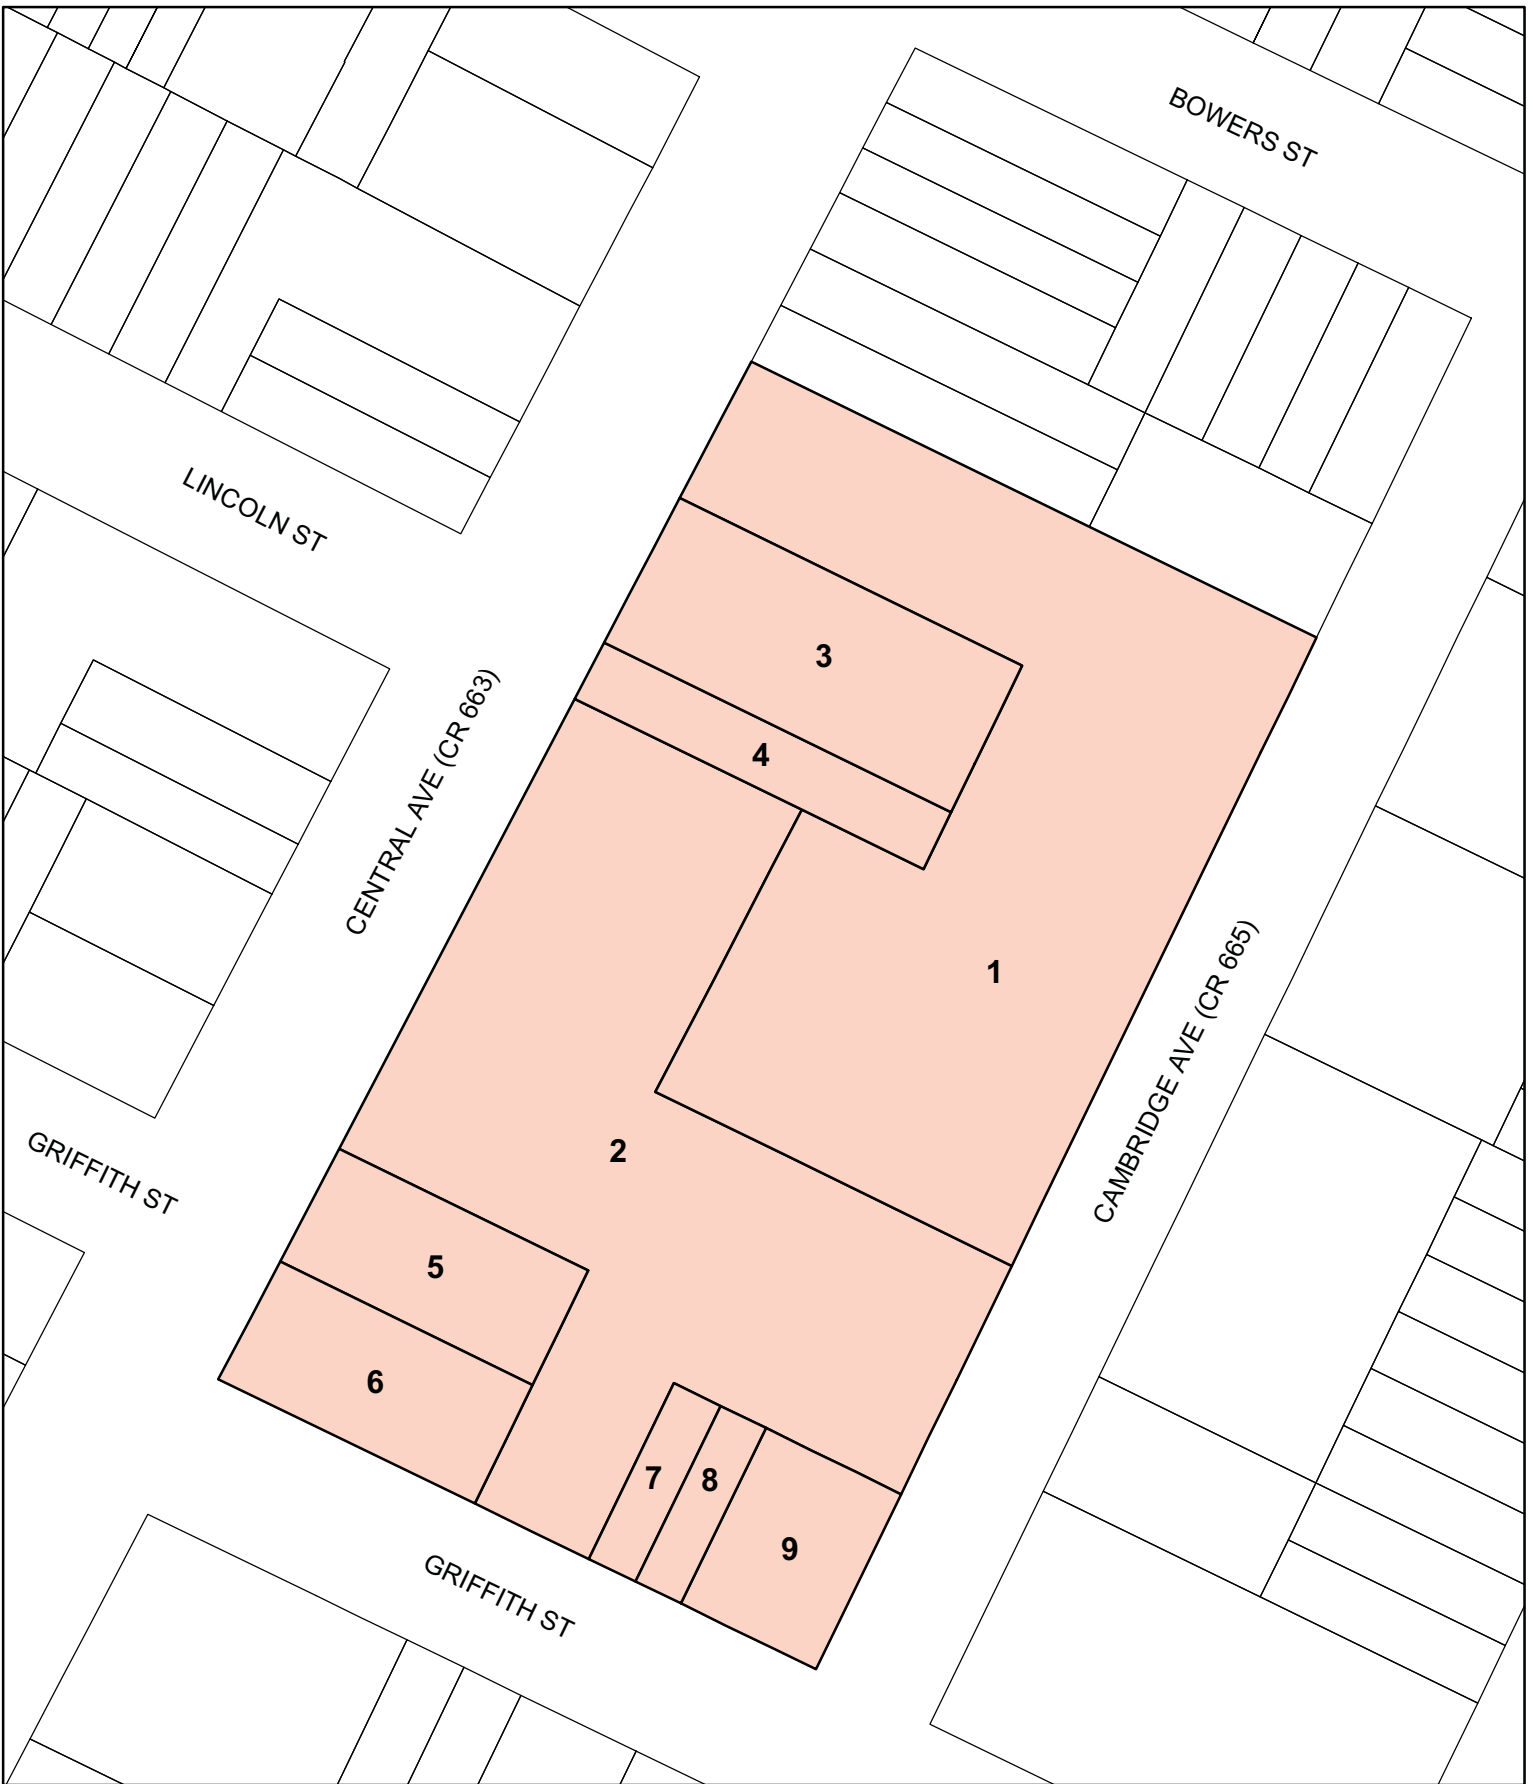
CENTRAL AVENUE BLOCK 2901 STUDY AREA
MAP B: SITE MAP

Below is a description of each property and a discussion as to which criteria each property meets to be designated as an area in need of redevelopment. The Study Area was broken down into 9 sites for this analysis as depicted on Map B and Map C in Appendix 1 of this study. Properties or sites are listed as being in Good, Fair or Poor condition and are summarized in the conclusions below. Photo documentation of each site is located in Appendix 3 of this study.
