MADONNA DESIGNS

St. Peter's Prep Grammar School Report 2/1/16

St. Peter's Grammar School

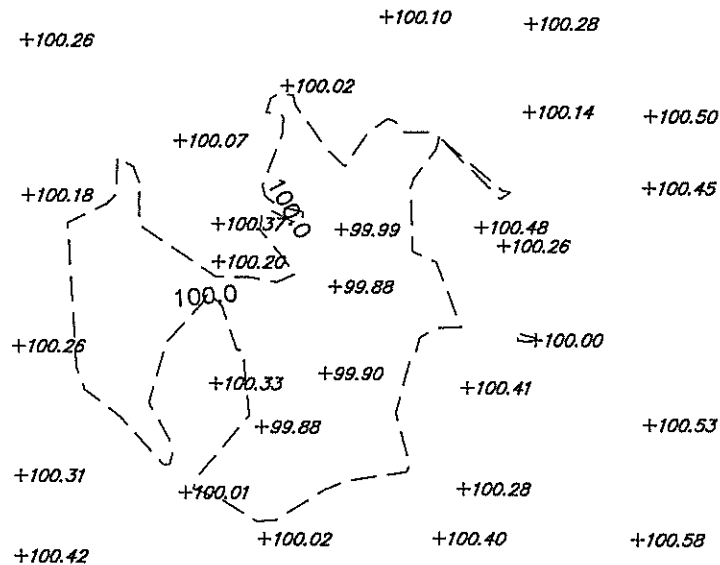
BASEMENT
SCALE 1" = 20'

The attached diagrams delineate the structural deficiencies. In the main cellar beneath the auditorium, the soil has eroded around all the columns creating an undulating slab. The columns while still supported by the timber piles now have little lateral support. The staircase along York Street at the main school entry has also sunk. The floor of the auditorium severely slopes to the stair whose foundation is now undermined. There is no way to practically re-support this stair and stabilize the foundation beneath it.

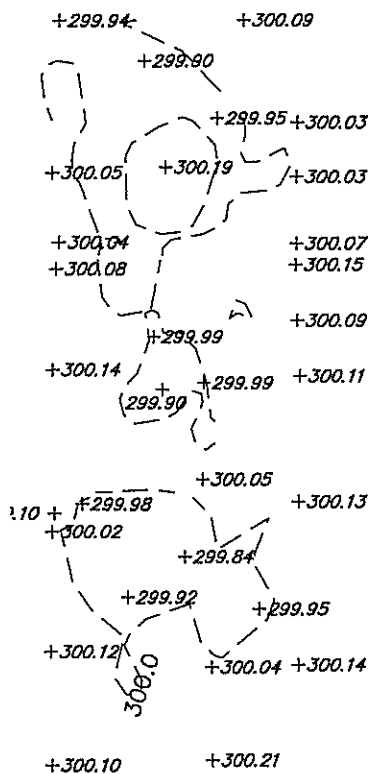
SECOND FLOOR
SCALE 1" = 20'

The west wall of the original school is bulging to the west with visible structural cracks displacing the staircase in the school extension. The stairs now are severely pitched. This original foundation wall which now sits on shifting soil is pushing on the corner structure.

The corner school extension has its own foundation and structural floor problems. All of the floors are considerably pitching west to the corner of the building. The floors are no longer level. These structural deformations are directly the result of the poor foundation and they strain the west façade on Van Vorst Street.

STAIR CASE SLOPER
BUCKLING W/ LARGE STRUCTURAL CRACKS

SEVERELY
SLOPED
FLOOR
